KNOLLY'S ROAD

STREATHAM HILL

Jomas Associates Ltd were commissioned to conduct a Ground Investigation, Ground Movement Assessment and Basement Impact Assessment on Knollys Road in the London Borough of Lambeth.

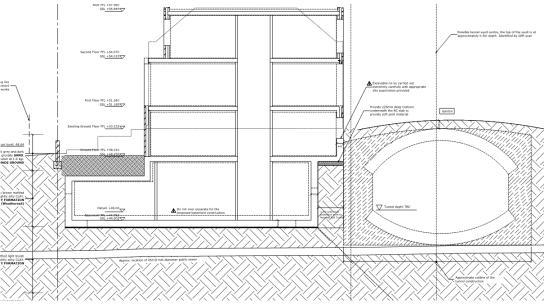
Proposed development

The Client proposed to demolish the existing property and construct a new residential dwelling with a single storey basement.

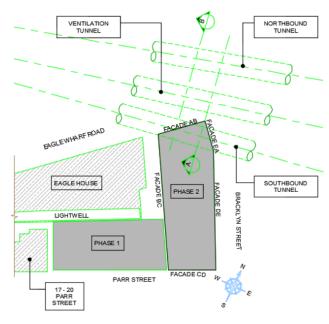
Plan of proposed development and CR2 tunnels.

The Jomas assessment evaluated ground deformations associated with an advancing tunnelling front beneath the proposed development. The effect of the greenfield ground movement settlement troughs on the development were assessed in accordance with the Burland damage classification system.

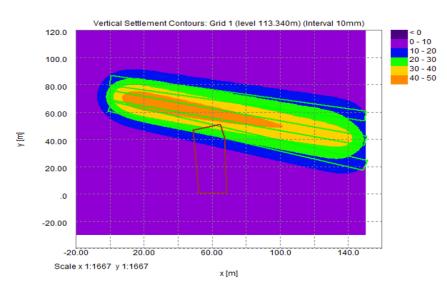
Vertical settlement contours produced by analytical model.

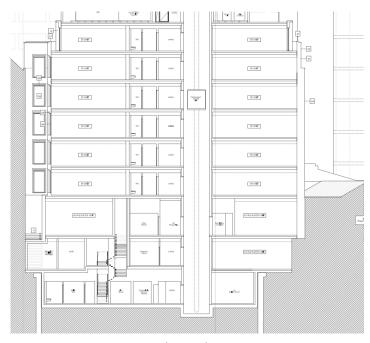
Proposed Developmentv

GROUND MOVEMENT ASSESSMENT FOR NEW 7STOREY BUILDING WITH TRIPLE LEVEL BASEMENT

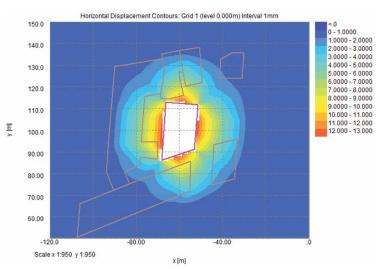
Resultant horizontal ground movement contours

The assessment concluded minimal impact on adjacent properties as a result of the proposed works, with maximum vertical and horizontal displacements of 22mm and 13mm calculated respectively.

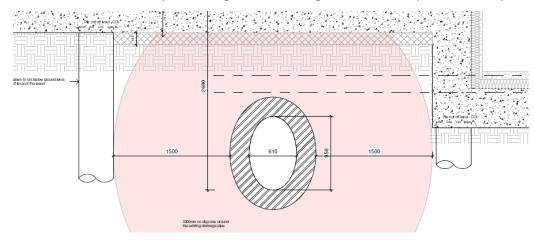
Section through existing brick sewer illustrating proposed build-over arrangement

Jomas, working closely with the contractor and structural engineers, was able to assist in developing an appropriate construction design including implementing a heave protection layer and non-sleeved piles in order to limit the stresses transferred into the soil mass ground the sewer.

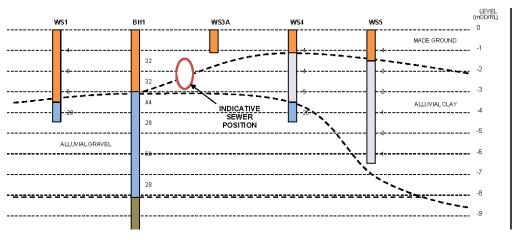
Geological cross-section based on Jomas' Ground Investigation

A detailed ground model and geotechnical parameters were produced using information obtained by Jomas' ground investigation, and adopted for analysis
