JOMAS | ENGINEERING
ENVIRONMENTAL

PROJECT PROFILES

LAND CONTAMINATION ASSESSMENTS
& REMEDIATION

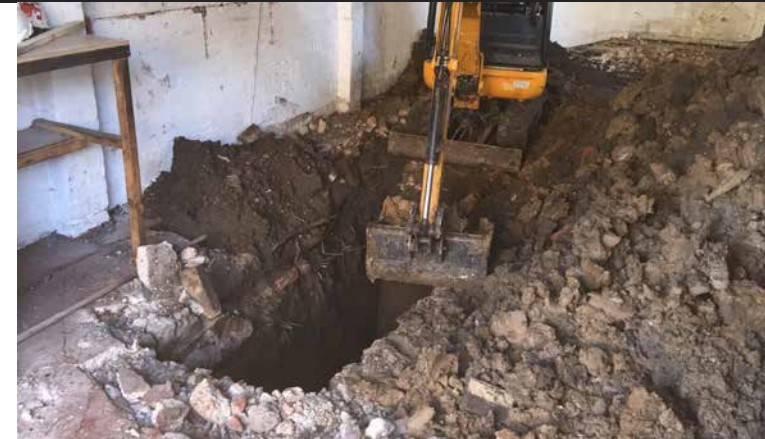
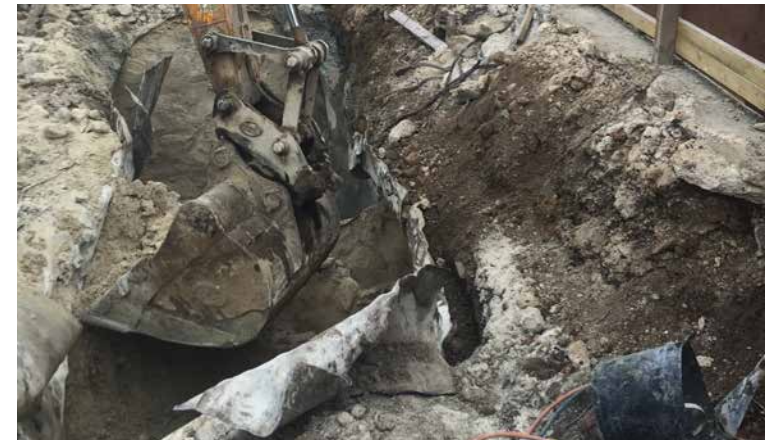
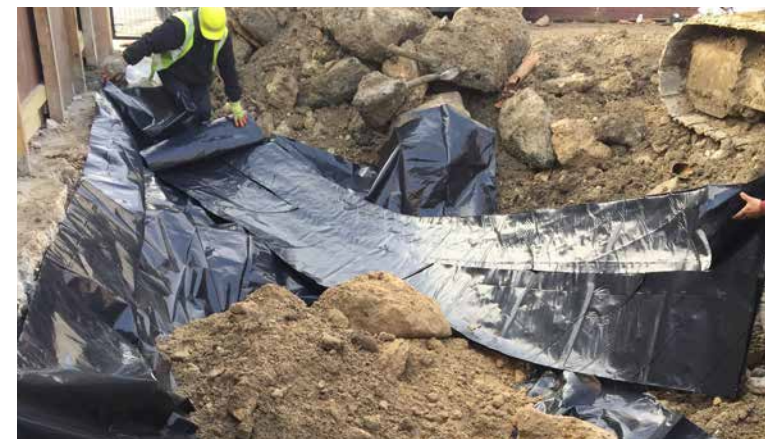
MILL ROAD

Jomas Associates Ltd worked closely with a demolition team. Buildings on the site were demolished. Jomas' engineers carried out site visits post demolition to assess underside of hardstanding. Trial pits were excavated to delineate areas of contamination. Samples were collected for laboratory testing. These were informed by on-site analysis using a photo ionisation detector, which provides an indication of significant volatiles in the ground.

Jomas Associates subsequently supervised the removal of the underground fuel storage tanks, an oil / water interceptor; and associated contaminated soils.

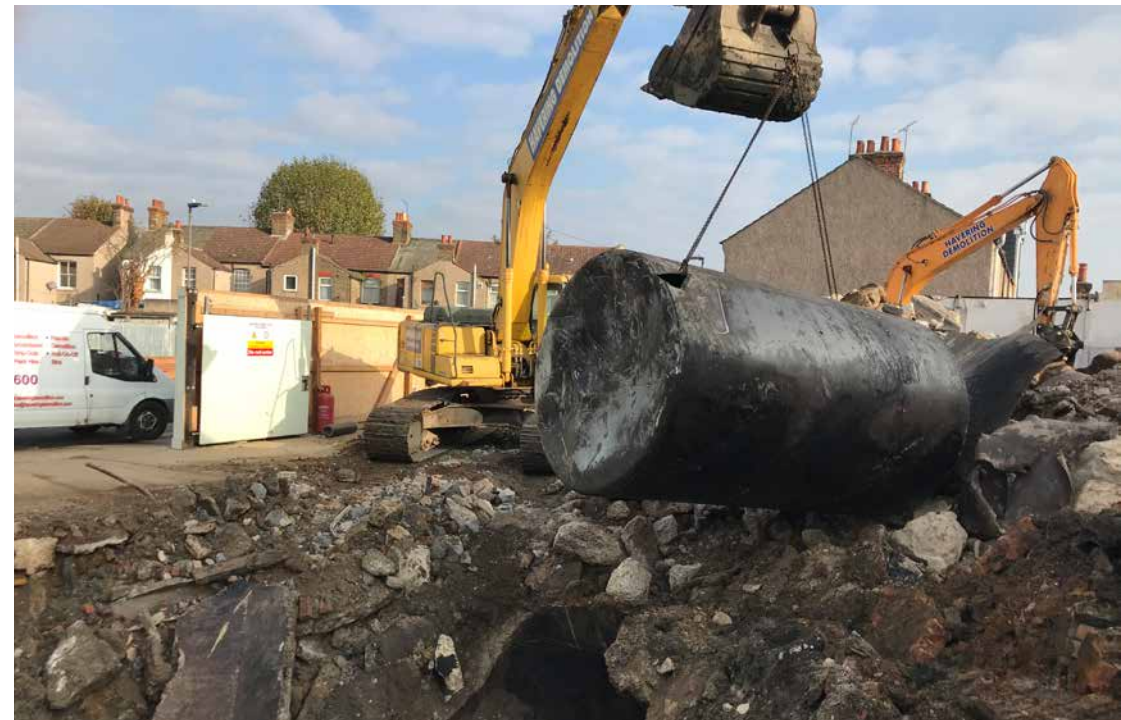
MOVERS LANE

Jomas Associates Ltd worked closely with a demolition team. Buildings on the site were demolished. Jomas' engineers carried out site visits post demolition to assess underside of hardstanding. Trial pits were excavated to delineate areas of contamination. Samples were collected for laboratory testing. These were informed by on-site analysis using a photo ionisation

Jomas Associates subsequently supervised the removal of the underground fuel storage tanks, an oil / water interceptor; and associated contaminated soils.

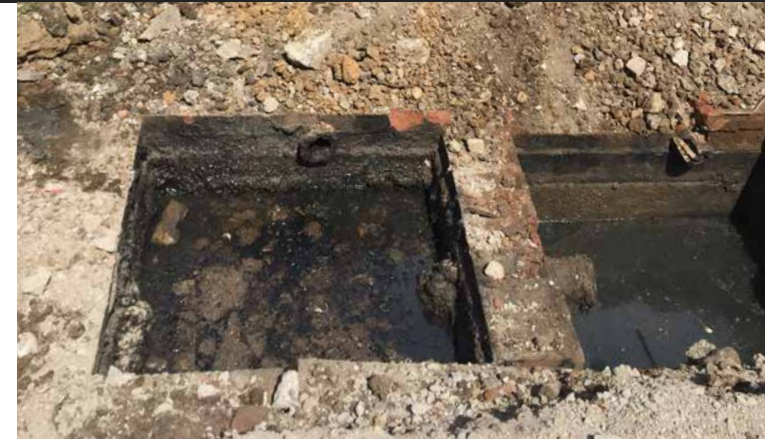
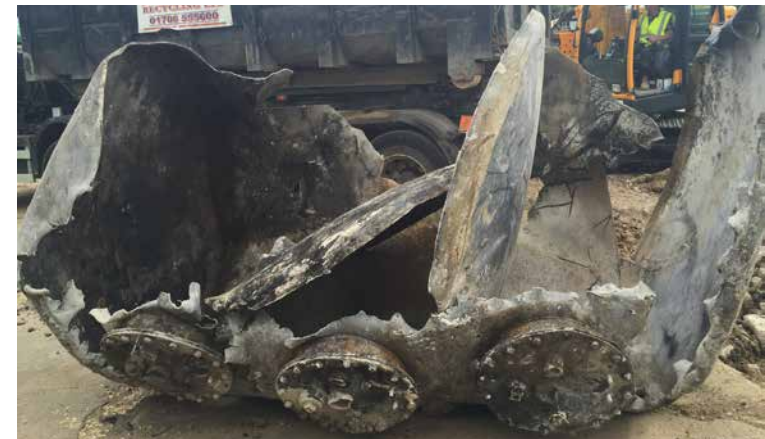
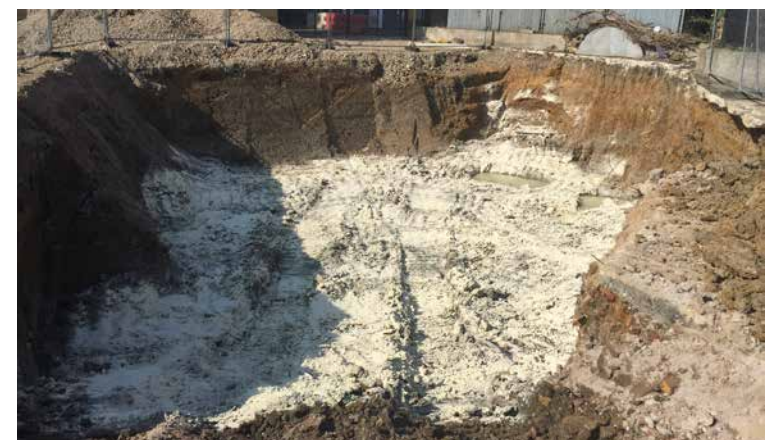
MONIER ROAD

Remediation comprised the removal of buried fuel tanks and immediately surrounding grossly impacted soils. Detailed Quantitative Risk Assessments (DQRA) were undertaken to demonstrate that full scale groundwater remediation was not necessary across the site. The DQRA showed that the site had elevated concentrations of Benzene and TCE in the groundwater on part of the site, which required remediation. Groundwater remediation comprised the application of chemical oxidation additive directly to the contamination in the dissolved phase groundwater, which reduced the chemical concentrations. Application was via a combination of direct tank void application, existing monitoring wells and direct push application on a 3m x 3m grid in the vicinity of the highest concentrations.

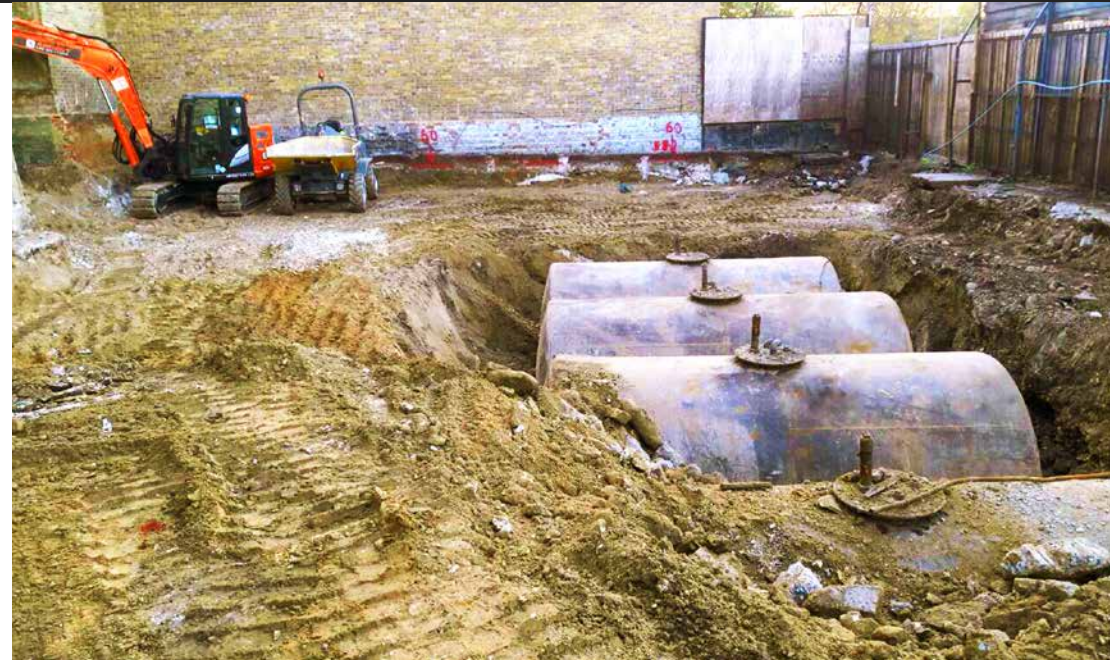
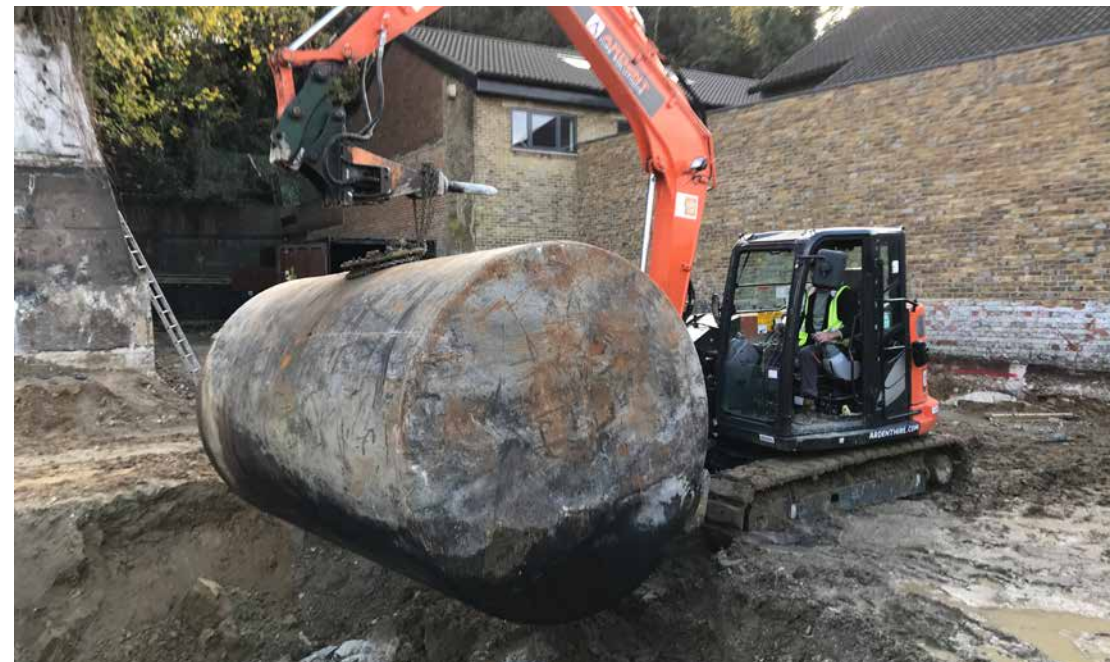
WOOLWICH ROAD GREENWICH

Remediation comprised the removal of 4No water filled underground fuel tanks. Samples were taken at the bases and sides of excavations, and screened by photo-ionisation detector as part of the verification process. It was determined that impacted soil removal was not necessary. A clean cover system was recommended in areas of soft landscaping.

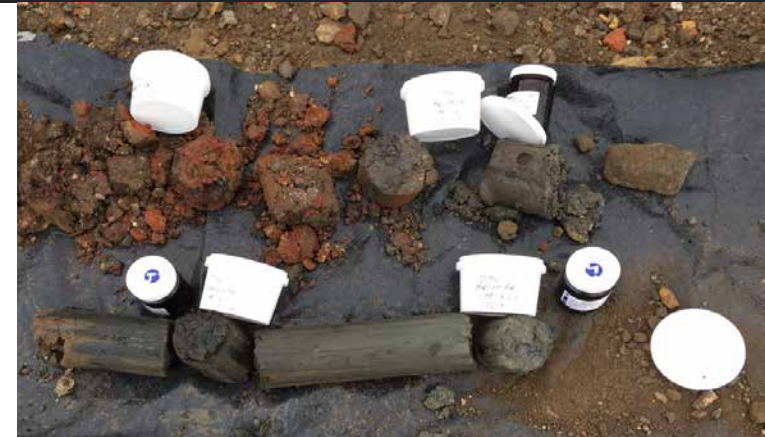
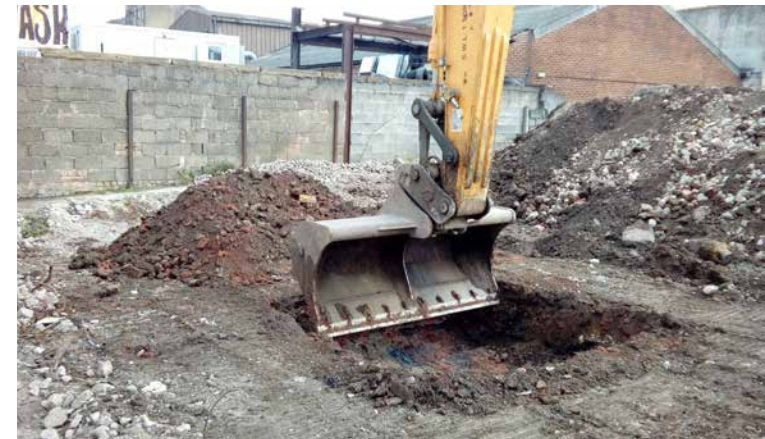
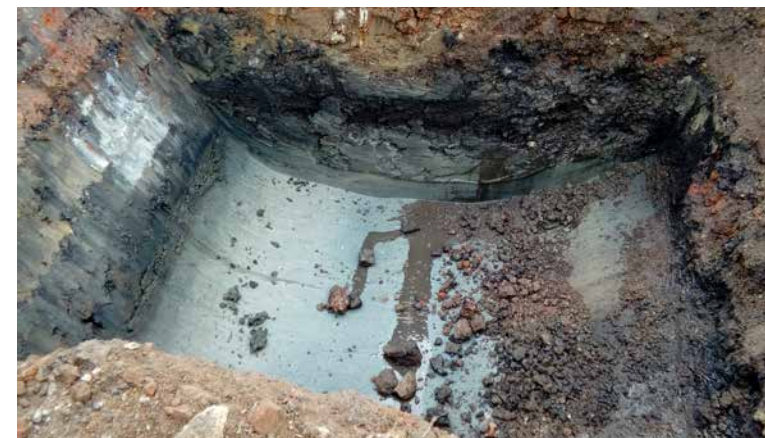
HEPSCOTT ROAD

Jomas completed windowless sampling and cable percussion boreholes across the site to enable soil and groundwater sampling as well as soil gas/vapour analysis. Groundwater was encountered in both of the cable percussive boreholes and four of the windowless sampler holes during the course of the investigation. Following generic risk assessments and statistical analysis, elevated concentrations of chromium, lead, mercury and a number of polyaromatic and total petroleum hydrocarbon fractions were reported in excess of Generic Assessment Criteria (GAC). A detailed quantitative risk assessment was undertaken in order to derive site specific remedial targets for the validation of soil removal works and for the protection of controlled waters receptors, to be used within the validation process.

The remediation strategy required a 3x3m area to be excavated until groundwater was encountered. Contaminated soils were removed for offsite disposal. Validation samples were then obtained from the focus of the void and scheduled for validation testing. The results were compared to generic criteria for the protection of human health and site specific criteria for the protection of controlled waters.

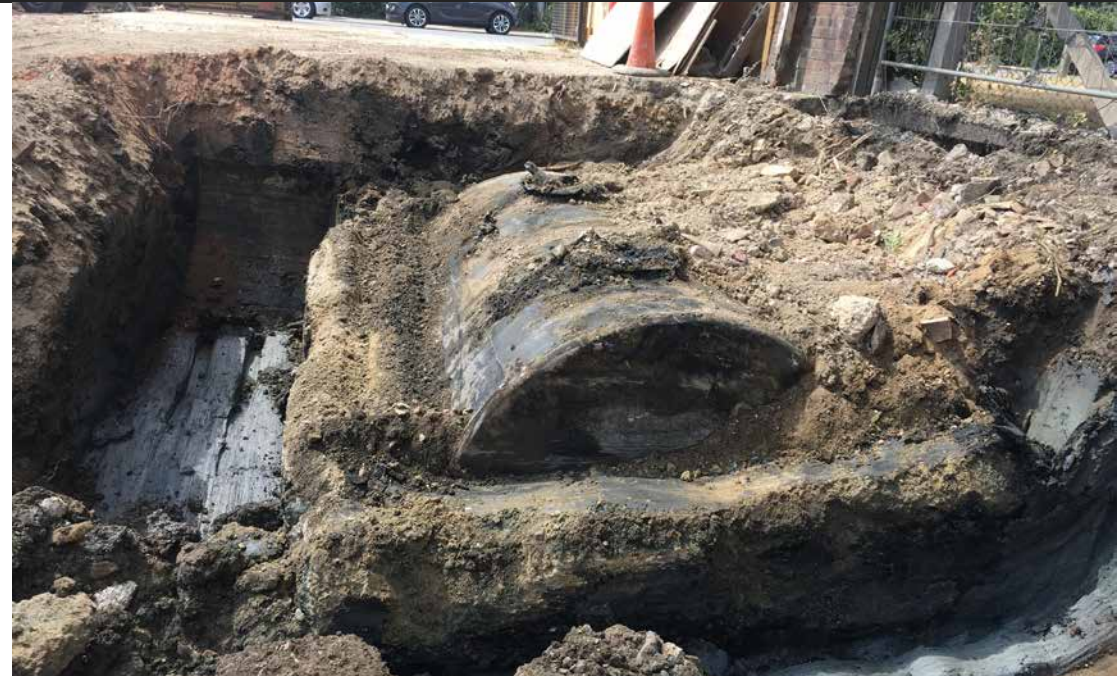
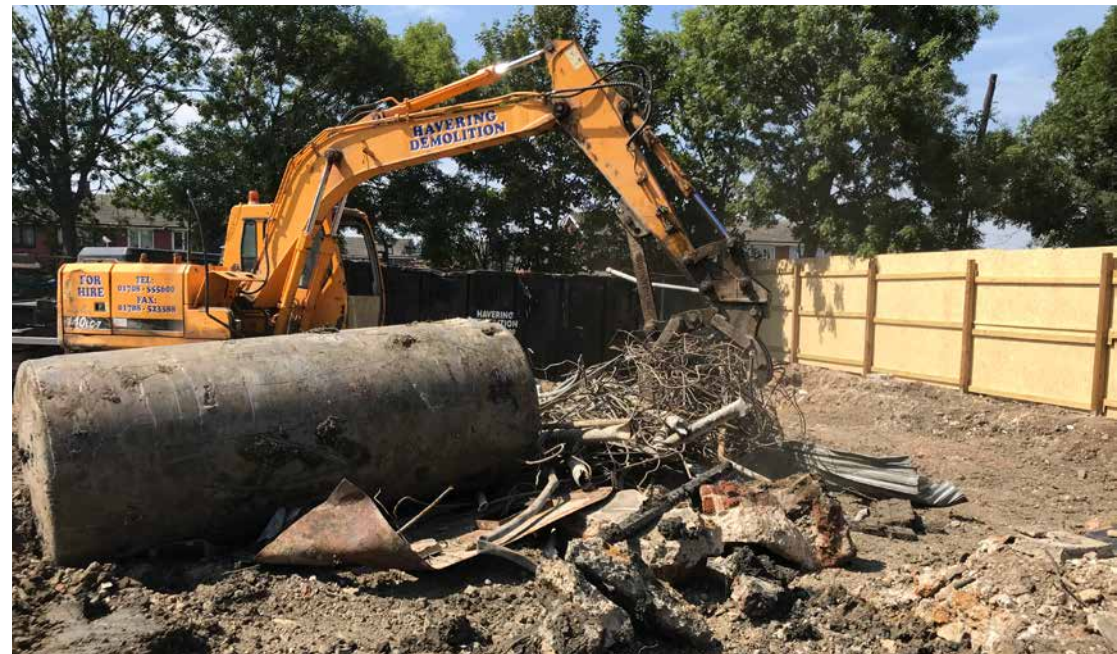
DOCK ROAD

Jomas Associates subsequently supervised the removal of the underground fuel storage tanks, interceptors, associated infrastructure, and hydrocarbon impacted soils, as well as the removal and off-site disposal of a concrete foundation slab with embedded asbestos cement.

Upon confirmation that tanks and soils were sufficiently removed, The excavation were backfilled with suitable granular clean material. A verification report was produced for regulatory sign off.

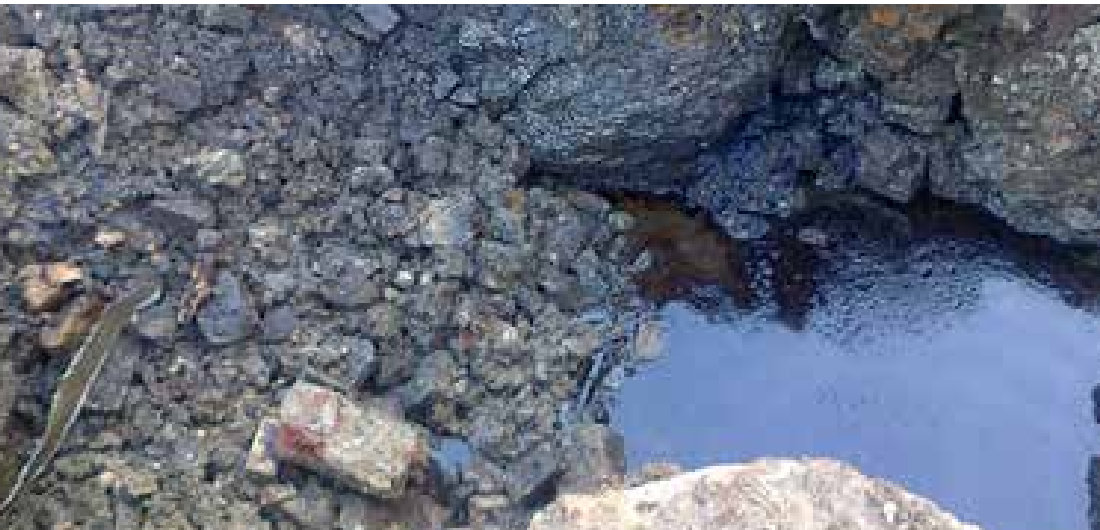
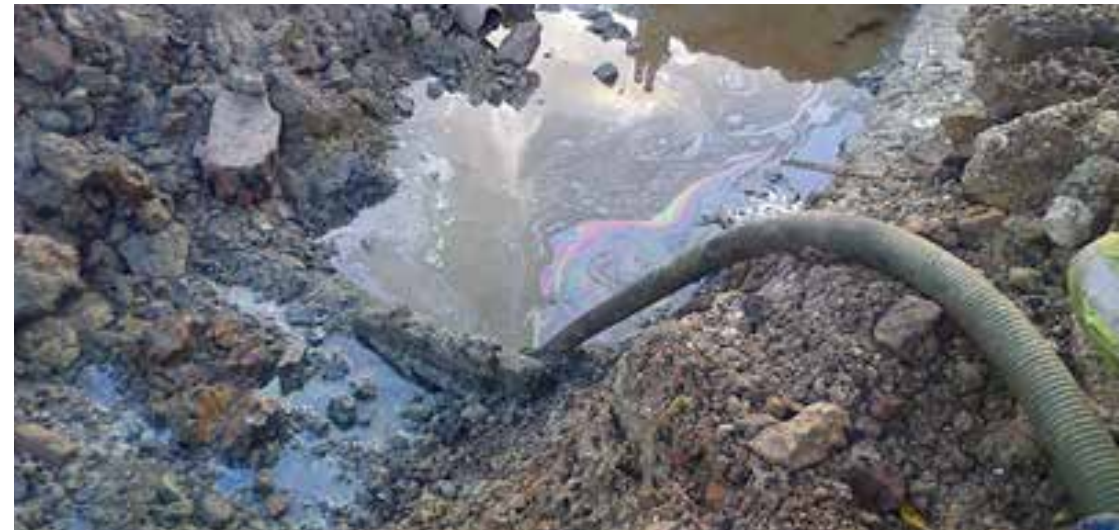
BROOK STREET

Historically, the site was part of a former Gas works. The results of Jomas' investigation indicated the site to be overlain by an initial covering of Made Ground up to 2.0m bgl in depth, overlying a structureless clayey chalk. Evidence of contamination in the form of visual staining and a noticeable hydrocarbon odour was reported within the majority of trial pits and boreholes, at depths ranging from 1.0m to 6.0m bgl.

The basement construction was undertaken under the supervision of Jomas Associates, to ensure remnants of the gas works, as well as impacted soils were removed and validate. The site was underlain by a Principal Aquifer, contained within the Chalk underlying the site.

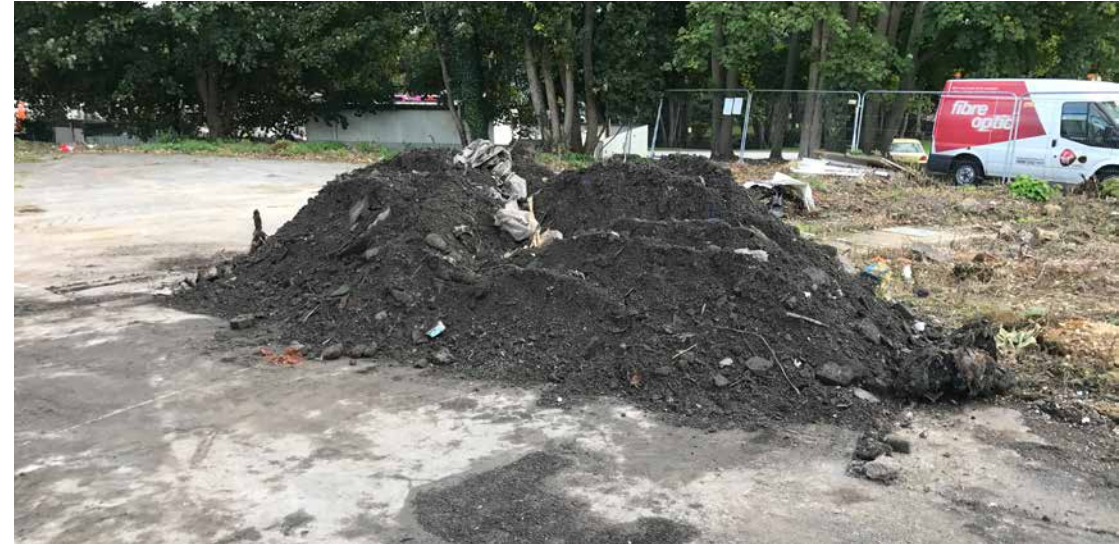
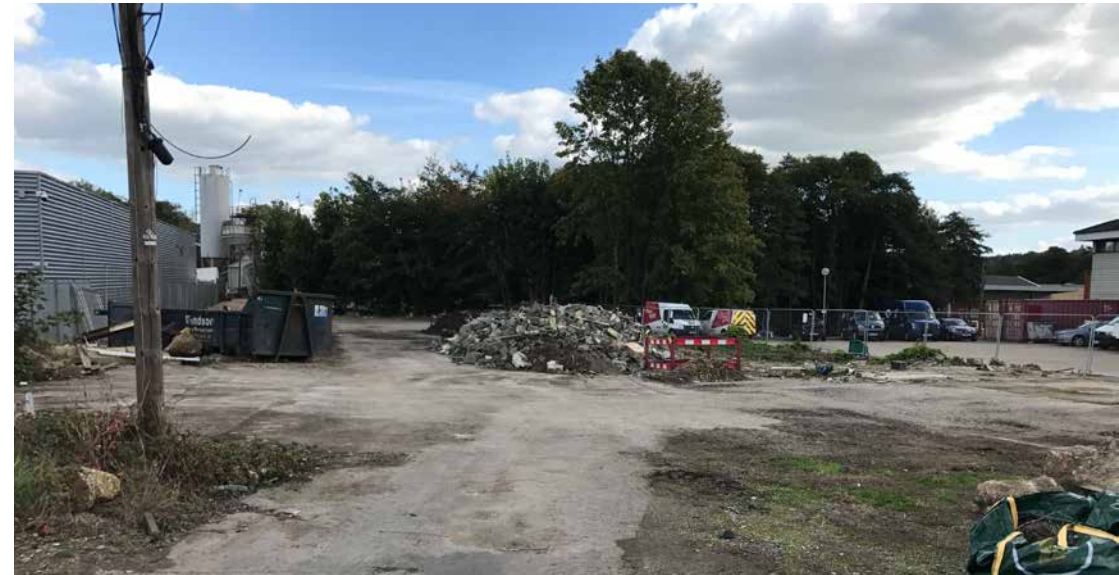
OPUS BUSINESS PARK

Jomas were commissioned to assess and remediate approximately 1000m³ of demolition material present on the site in Guildford.

Jomas mobilised a team to site to undertake a hand picking exercise, to remove visible asbestos fragments within the materials.

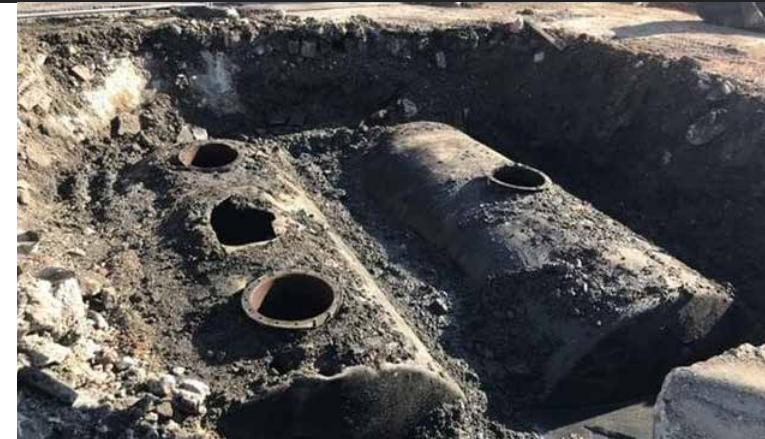
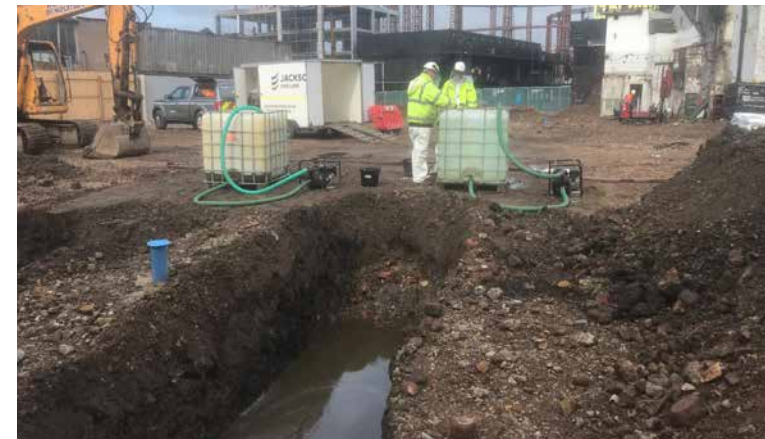
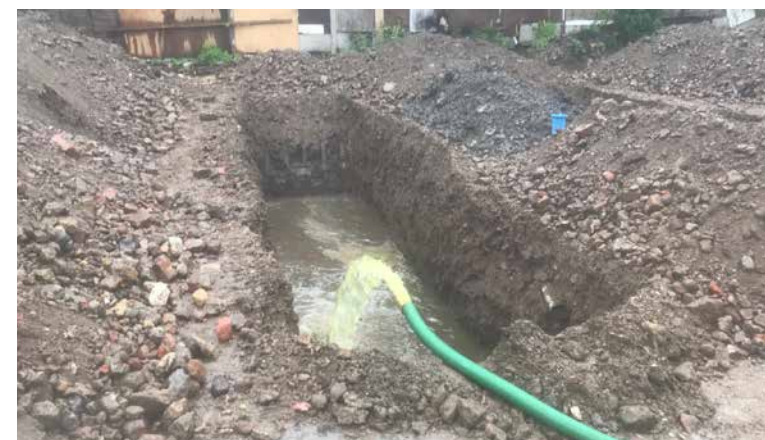
CORBRIDGE CRESCENT

This desk study was followed by a preliminary ground investigation, working around ongoing site use, and consisting of windowless sampler boreholes, cable percussion boreholes and installation of gas and groundwater monitoring wells.

Visual and olfactory evidence of contamination was encountered across the site, but particularly in proximity to known buried tank locations. Assessment of chemical testing results against generic assessment criteria indicated elevated levels of lead, mercury, a range of polyaromatic hydrocarbons and all petroleum hydrocarbon fractions. Groundwater sampling indicated the presence of free-phase hydrocarbons on the surface of the water table and subsequent analysis reported elevated levels of petroleum hydrocarbons and volatile organic compounds.

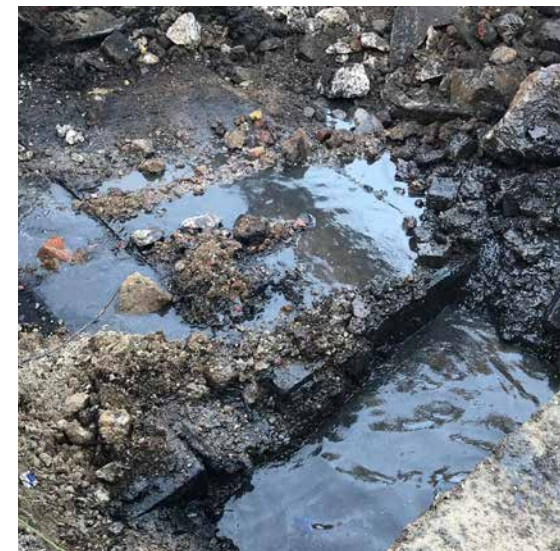
WALLIS ROAD

An intrusive ground investigation was undertaken which included a series of window sampler boreholes and cable percussive boreholes. The investigation identified significant contamination, within shallow soils, as well as perched groundwater and the underlying aquifer within the Alluvial soils & River Terrace Deposits underlying the site.

A Remediation Strategy was derived to remediate the site to render it suitable for the proposed use. The methodologies to be employed include excavation of grossly contaminated soils, skimming and pumping of free phase product, and chemical oxidation of contaminated groundwater. Ex-situ on site remediation was not considered appropriate due to time constraints for development to progress, and odour sensitivity of the site.
